POCKETS OF RESILIENCE:
SMALL-SCALE CITIZEN DRIVEN LID PERFORMANCE
IN THE URBAN LANDSCAPE

Adele Pierre MLA OALA ISA
in partnership with
Green Venture Hamilton
Contributing Staff: Liz Enriquez, Jessica Gale, Alexia Da Poupada
December 2025

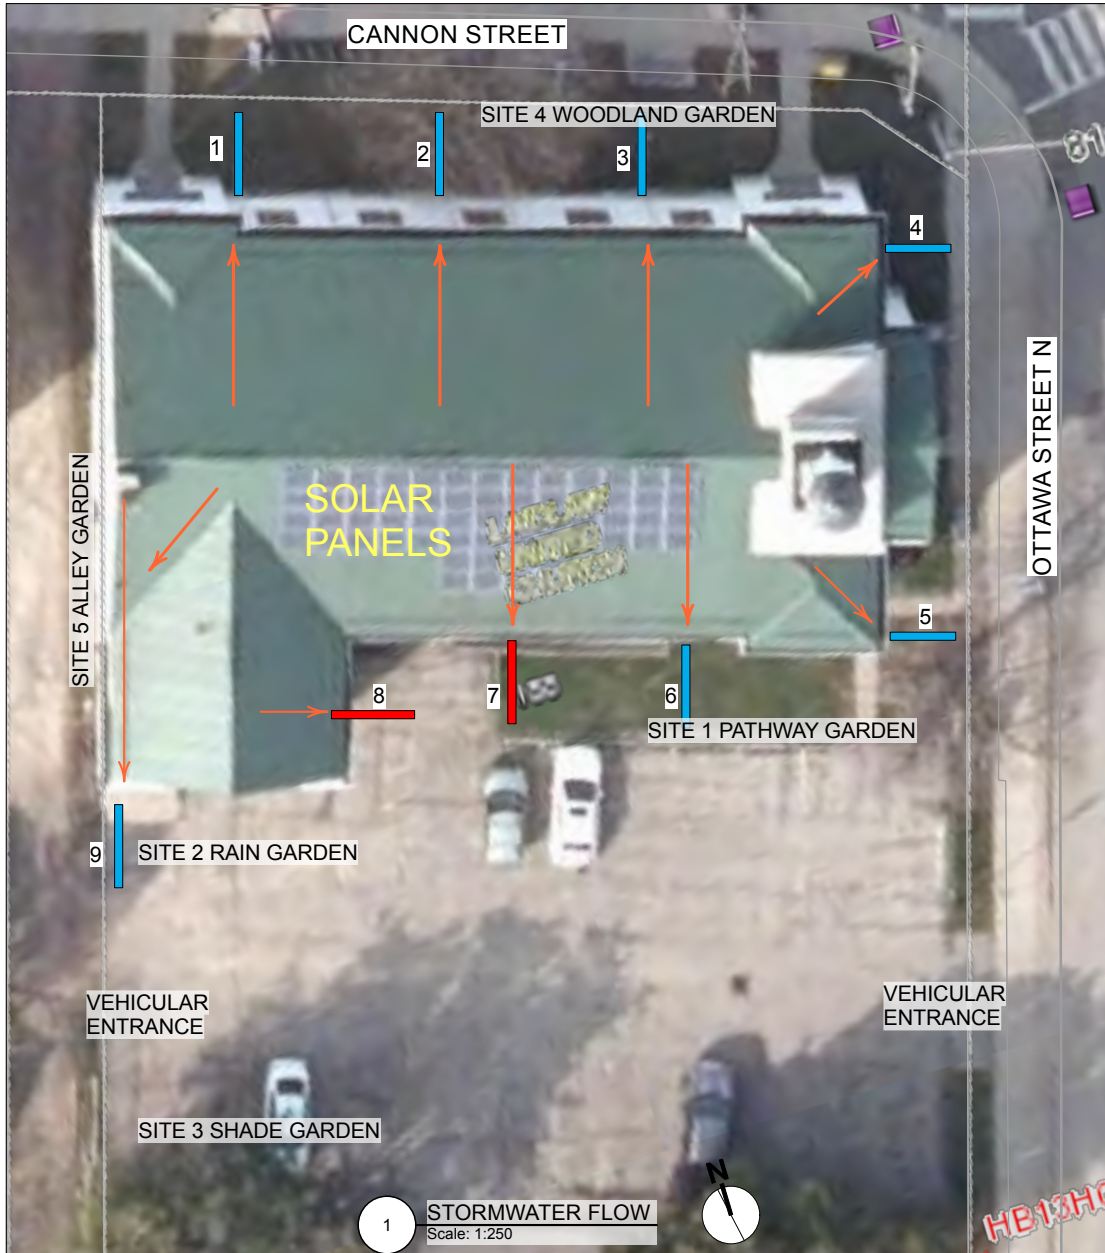
Figure 2 Stormwater discharge

The site of Laidlaw Memorial United Church at 155 Ottawa N provided an opportunity to engage with a community already attuned to reducing its environmental impact. Out of the necessity to reduce costs attendant on an ageing building, congregants have worked together to maintain facilities and reduce energy costs. A grant for solar panels provided the means for a new roof. Disconnecting six downspouts from the city sewers helped to reduce flooding around the building. (Figure 2).

ROOF DRAINAGE AND EXISTING DOWNSPOUTS

- DOWNSPOUT DISCONNECTED : #1-6 DISCHARGING TO TURF, #9 DISCHARGING TO ASPHALT
- DOWNSPOUT DISCHARGING TO COMBINED SEWER: #7 & #8
- DIRECTION OF STORMWATER FLOW

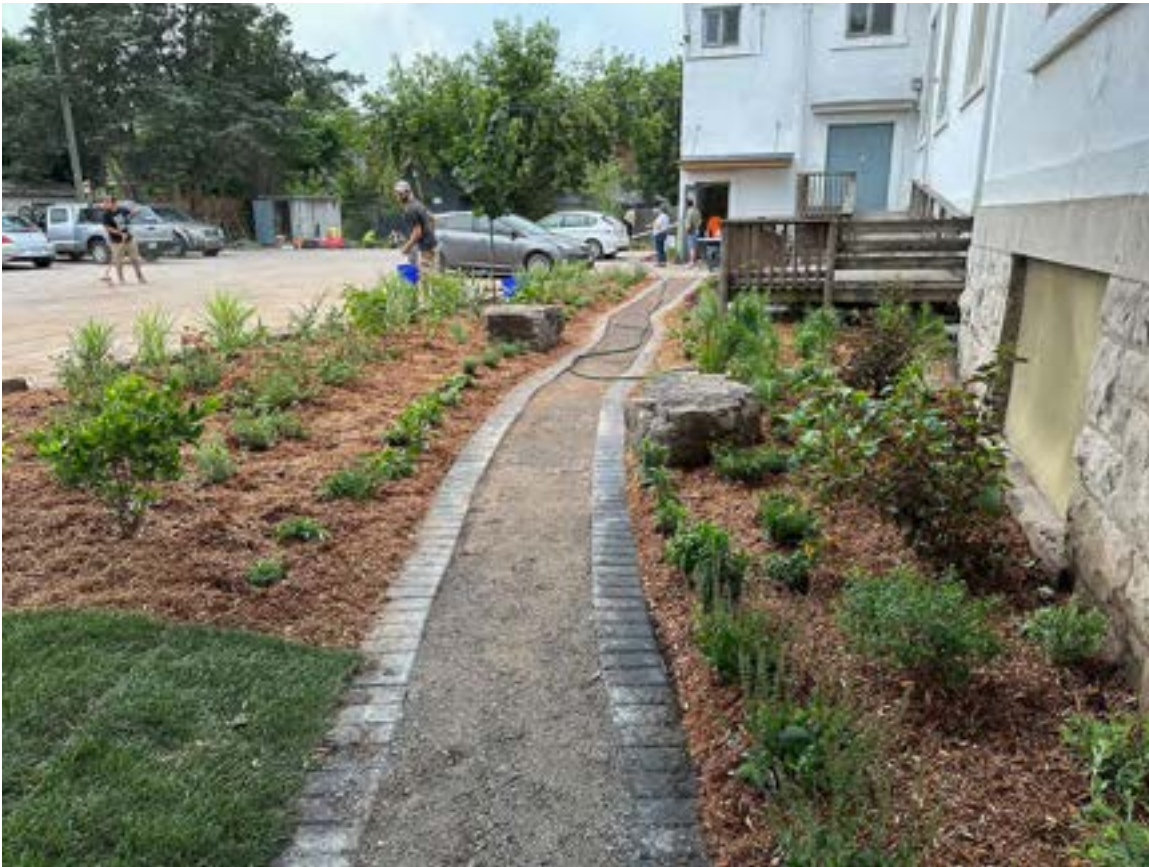
- Turf and small area of asphalt (6m²) replaced by new plant beds; high percentage of native plants used.
- Small concrete pathway removed and replaced with permeable walkway. Walkway is composed of limestone screenings sealed with a binder which allows water to flow through.
- Downspout #5 disconnected and connected to the Rain Grid Cistern with a 500 litre (132gal) capacity
- Rain barrel overflow is directed into new plant bed.
- Chain link fences removed
- Steps to accessibility ramp removed
- Native soil texture is sandy loam (62% sand, 26% silt, 13% clay) with good permeability. It was amended with top dressing of compost to replace organic matter lost through removal of turf.

Image 9 Permeable walkway, new plantings

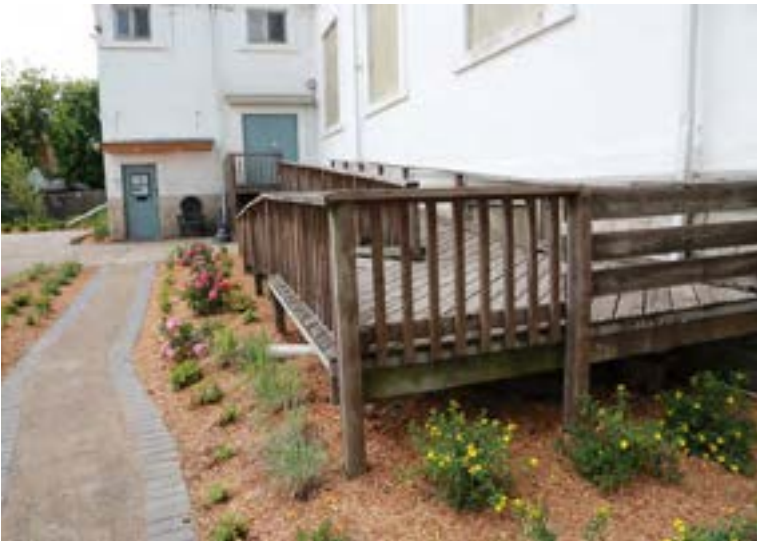
*Image 11 Permeable walkway
Downspout not yet connected to rain barrel*

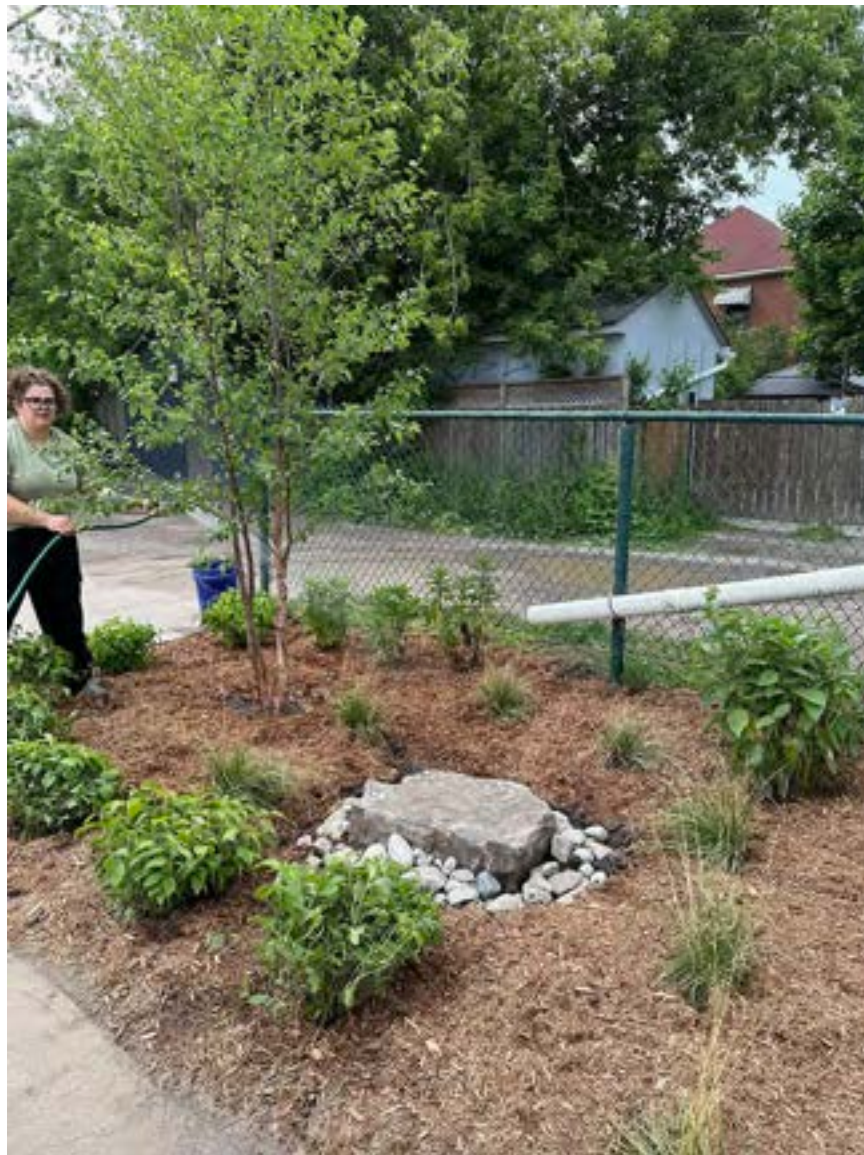
- Concrete shed was relocated to Site 4
- 22.6m² of asphalt and all associated granular material was removed to a depth of approximately 60cm
- The excavation was filled with triple mix consisting of equal parts top soil, loam and compost sourced from a local soil supply company
- No further excavation was required for the rain garden, however the surface was graded from edge of asphalt to centre of bed allowing for 150mm of ponding
- Downspout was redirected to the centre of the bed, with rainwater exiting onto a boulder before entering the soil
- Plantings consist of native species and some cultivars of native species, all tolerant of occasional flooding

Image 16 Rain garden installed, downspout not yet redirected

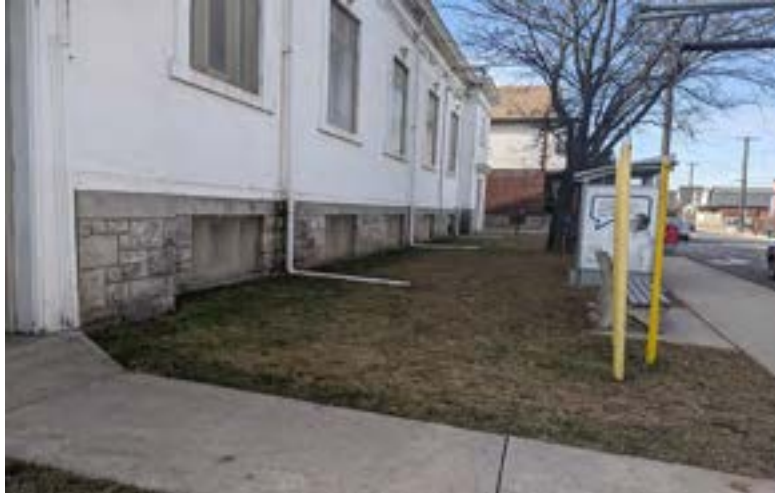
- Partial to full shade
- Turf grass in poor to fair condition
- Three disconnected downspouts draining on to turf
- Hamilton Street Railway bus stop and shelter
- Mature *Gleditsia triacanthos* var. *inermis*

Image 20 Three disconnected downspouts draining to turf

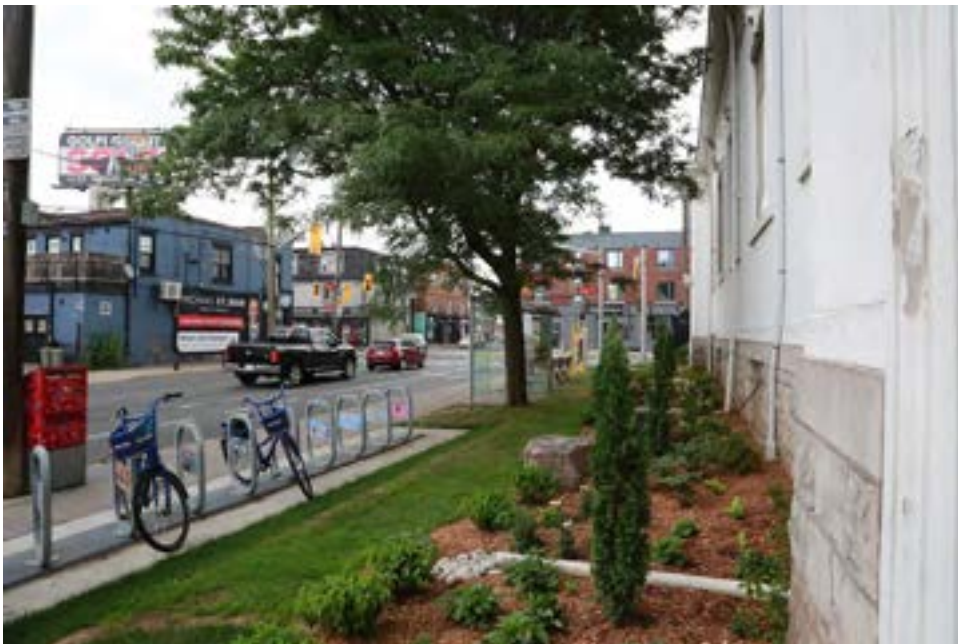
- Replaced 73.4m² of turf with plant beds
- Turf was removed and the soil modified with 100mm top dressing of compost
- Granular material was installed at mouths of downspouts to slow flow of water
- Native and non-native plantings were installed to infiltrate stormwater, provide pollinator habitat and create four seasons of beauty.
- Seating boulders were added to plant beds to create a shaded resting place by the bus stop.

Image 21 New plantings, water slowed at downspout termination

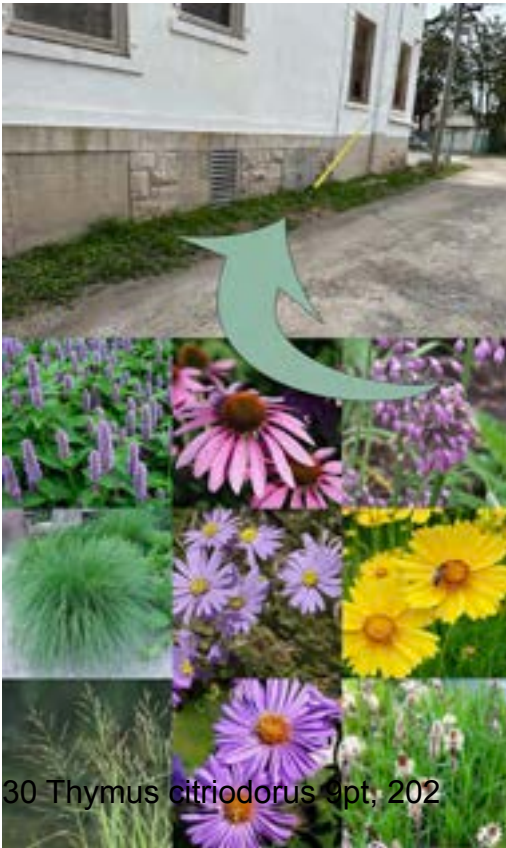
Image 22 Alley concept plan

- No soil remediation.
- Plants have been chosen to thrive in existing conditions (Rainer & West 2015) (Beck 2013)
- Intensive planting of native plant plugs

PLANT LIST

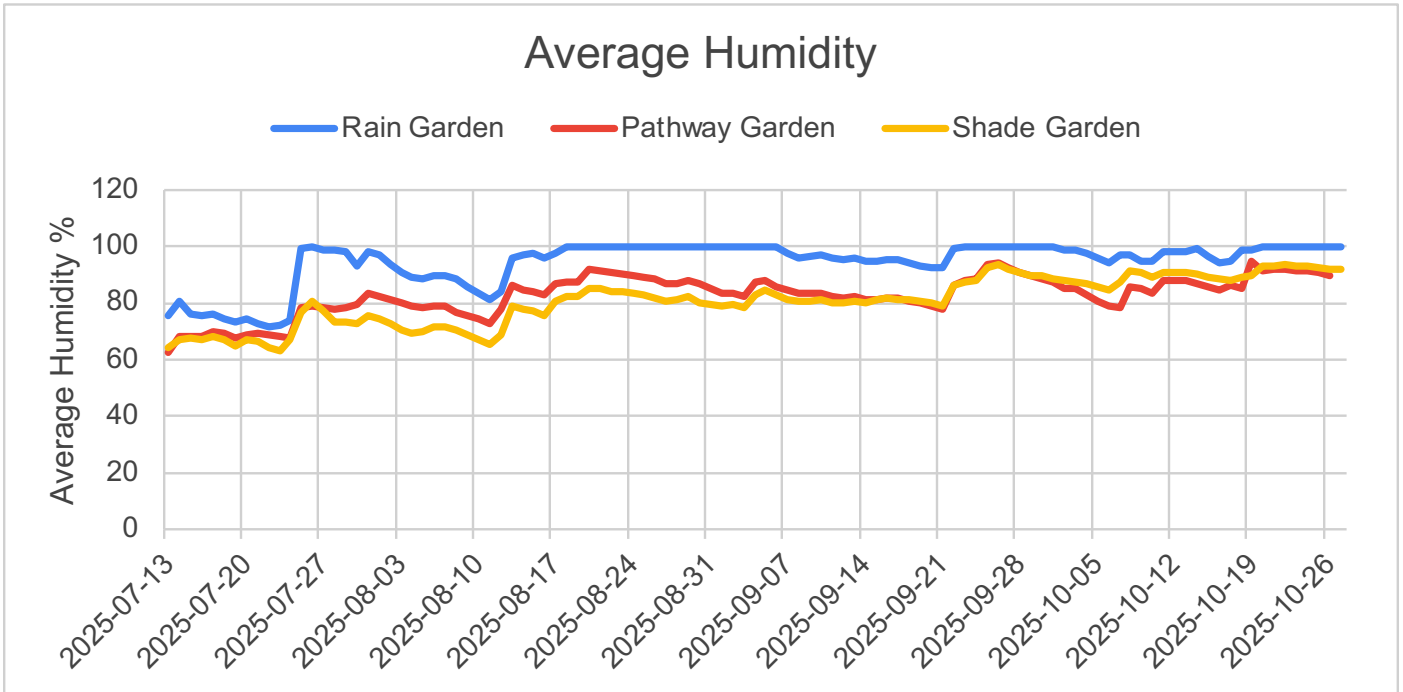
Figure 5 Average Humidity Comparison

The Rain Garden maintained consistently higher relative humidity compared to the Shade Garden, driven by its higher soil moisture content and active evapotranspiration. While the Shade Garden benefits from canopy cover, it cannot match the humidity-generation capacity of a moisture-retentive bioretention system. This performance difference reinforces the Rain Garden’s role as a microclimate stabilizer and moisture reservoir within the site.

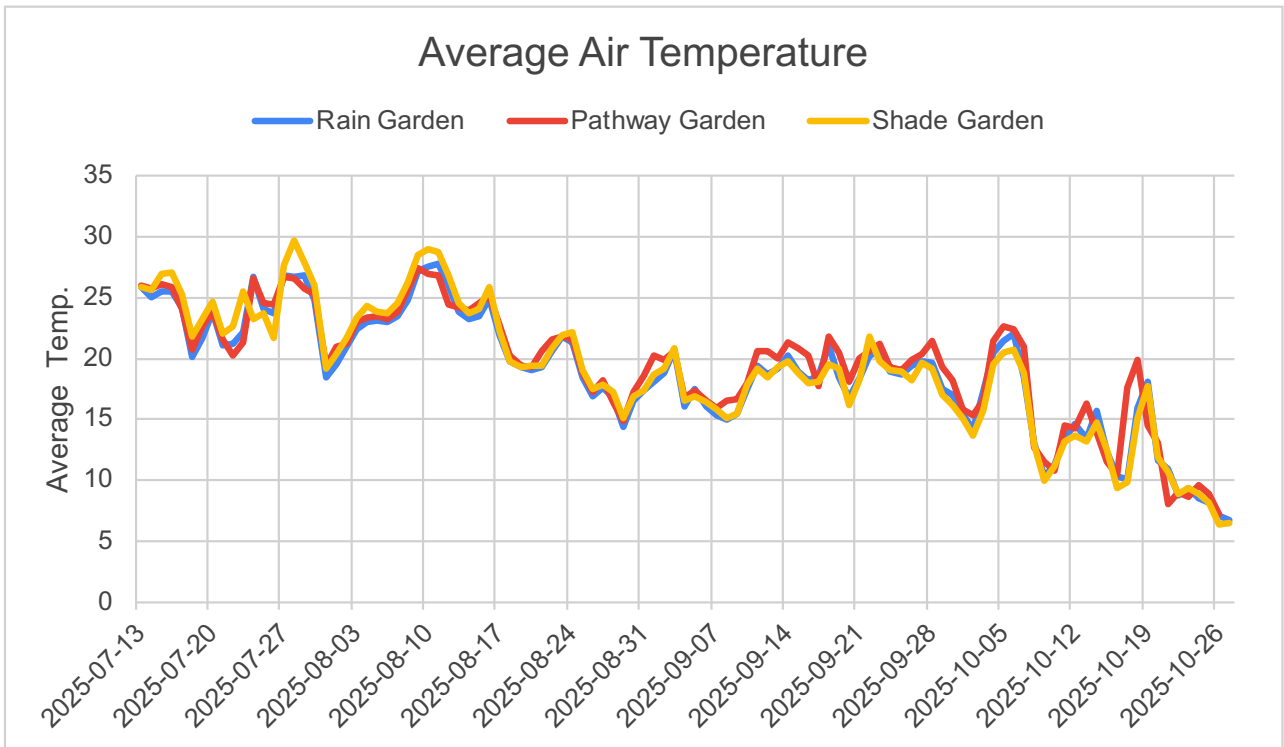
Figure 6 Average Air Temperature Comparison

No significant variation between gardens

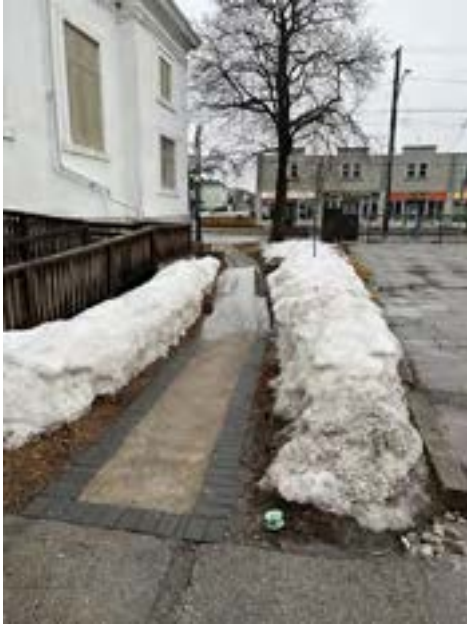
March 5, 2025 Temp. 3°C
Precipitation: Light Rain
Royal Botanical Gardens 20.1mm
Hamilton Munro Airport 23.1mm

*Image 27 Permeable Pathway March 5, 9:05am
Water pooling in lowest area*

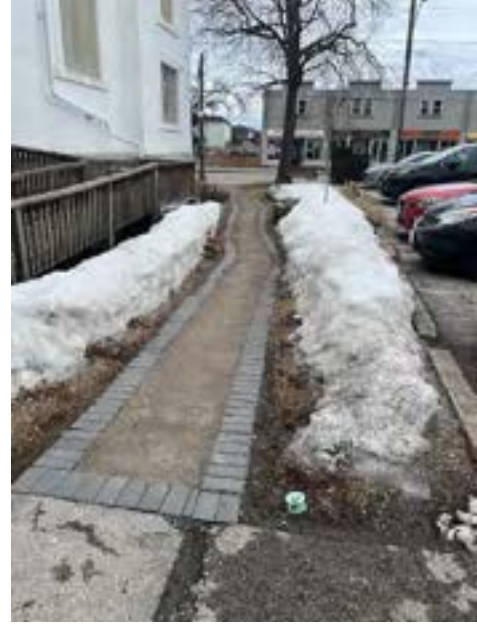
*Image 28 Permeable Pathway March 6, 10:10am
Water drained completely*

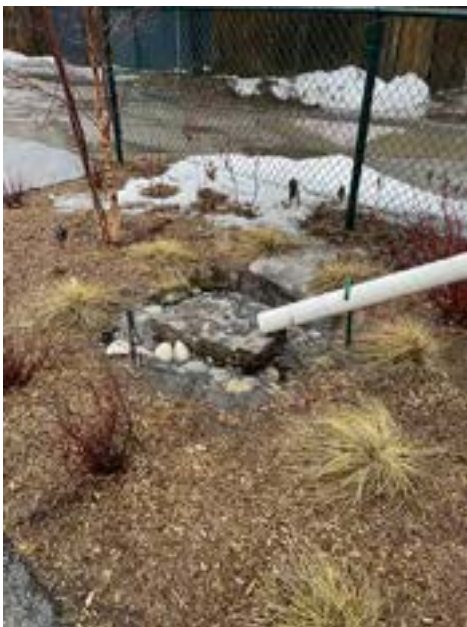
*Image 29 Rain Garden March 5, 9:05am
Water collecting at lowest point*

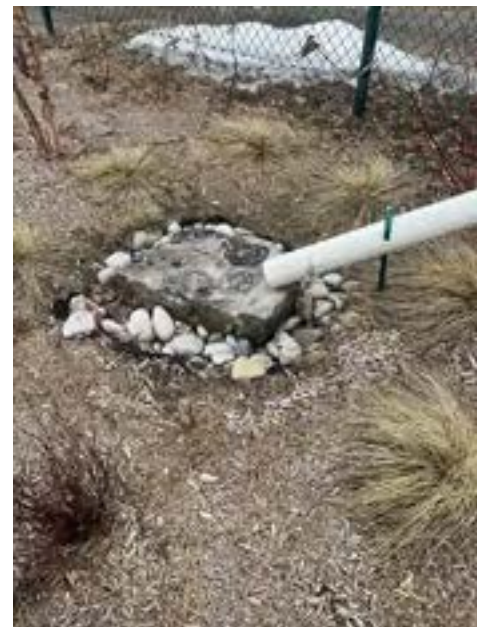
*Image 30 Rain Garden March 6, 10:10am
Water completely infiltrated within
24 hours*

Bioswales/Rain Gardens should infiltrate fully within 24 hours of the cessation of a storm event. (STEP, n.d. Bioretention). The Rain Garden infiltrated stormwater fully even in the shoulder seasons when ground was already carrying high levels of moisture. (Images 30, 32)

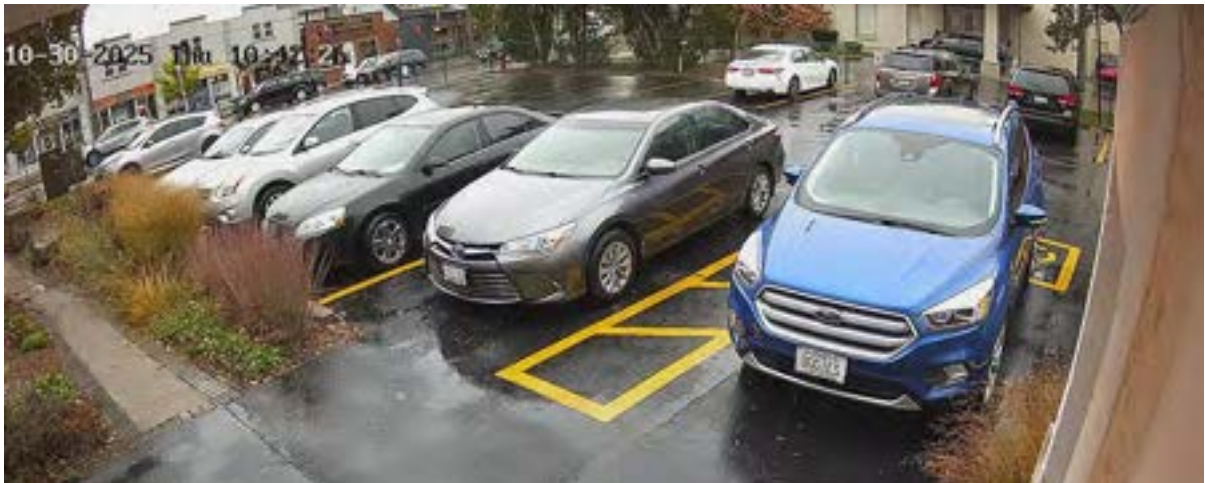
*Image 31 Permeable Pathway October 31, 10:42am
Slight pooling at lowest point*

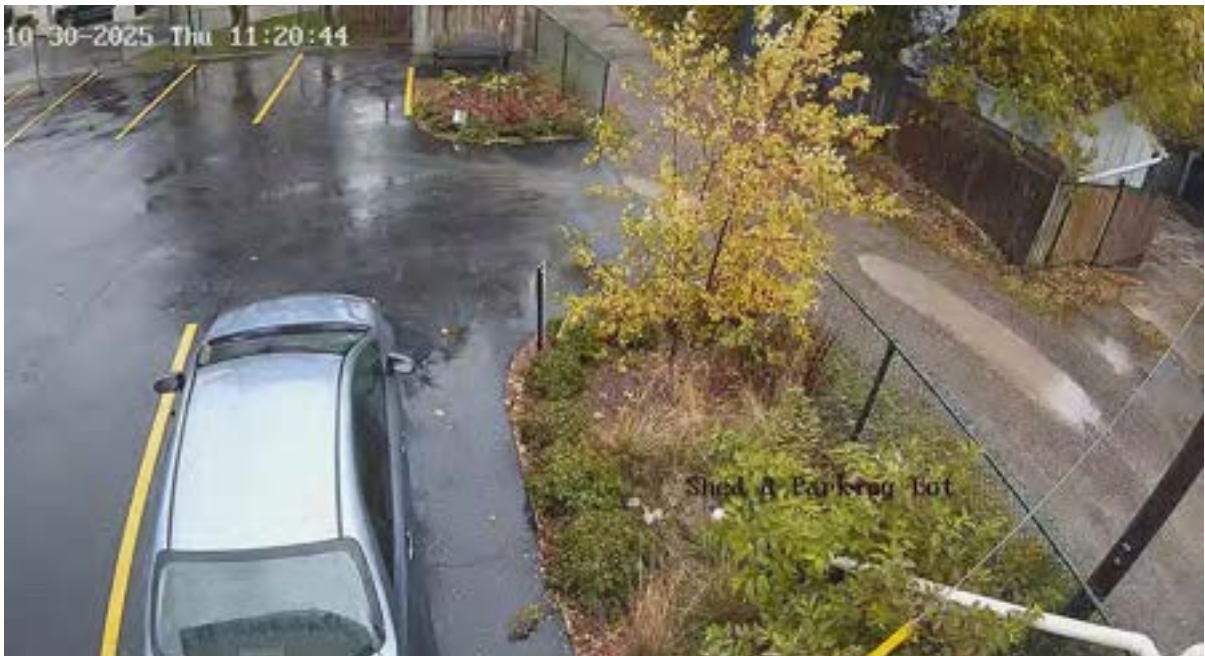
*Image 32 Rain Garden October 30, 11:20am
No overflow, rainwater from downspout appears to be totally infiltrated*

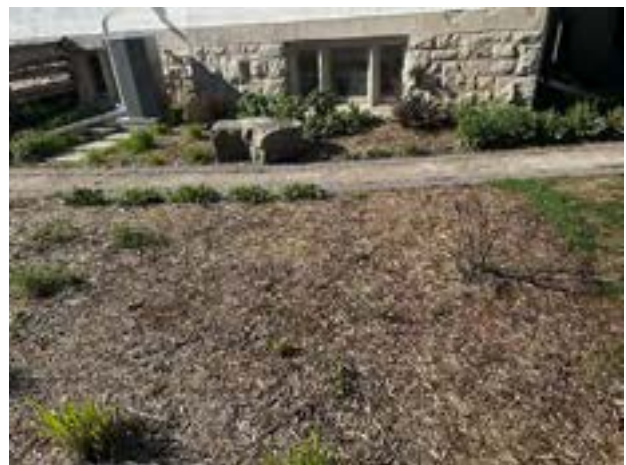
*Image 36 Losses near Acer platanoides;
many plants did not recover over the summer months.
Native grasses that thrived further away from Acer
maintained strong growth but reached only 50% of
mature height in this area.*

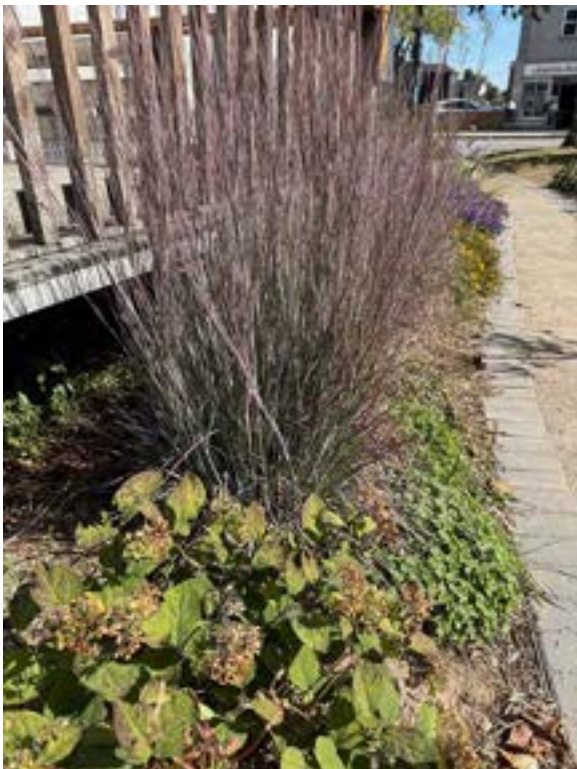
*Image 43 Schizachyrium strong; some hydrangeas recovering
A newly disconnected downspout #7 was directed to this area
in late fall and should strengthen plant growth in 2026.*

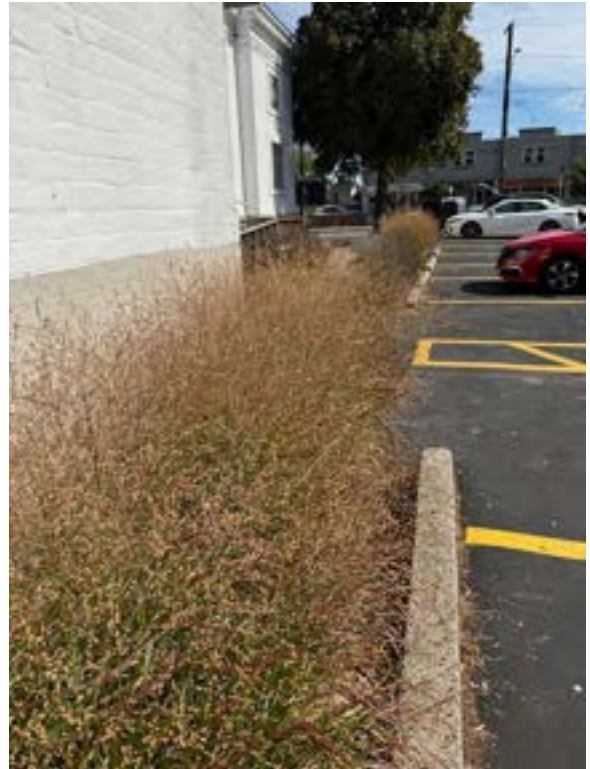
Image 50 Panicum virgatum provides strong linear element, infiltrates rainwater, no adverse effects from salt used on parking lot.
